PALLADIAN
HOME INSPECTIONS, LLC
148 Woods Way Dr Southbury CT
203-217-9450 adaigle242@charter.net

Confidential Inspection Report

Report: sample

April 1, 2013

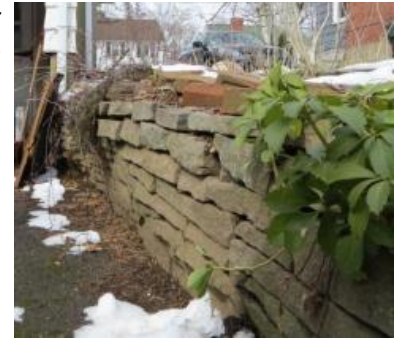
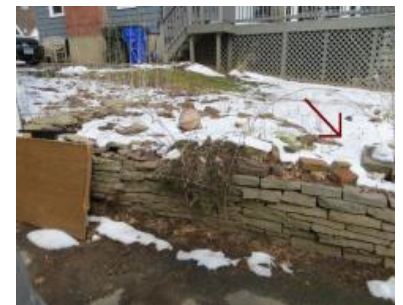
2.9 Condition of Wall and Materials Used:

The retaining wall is in need of some repair in order to function properly. The run-off water above the retaining wall needs to be redirected away from the wall. Recommend you have a landscaper repair the wall to keep it from collapsing and install drainage to keep this from causing future problems.

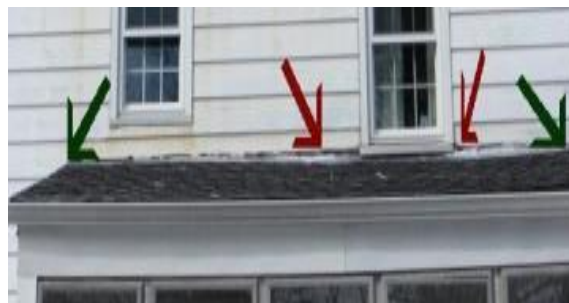
4.5 Roof Framing- Exterior Notes:

The roof over the back porch area is sagging in the center. The green arrows point out the original roof line. The red arrows indicate the center has sagged as seen in the picture where more of the wall flashing is visible. No leaking was visible from the inside of the porch. Recommend monitoring and if any further sagging is noted then a licensed roofing contractor should evaluate and make any necessary repairs.

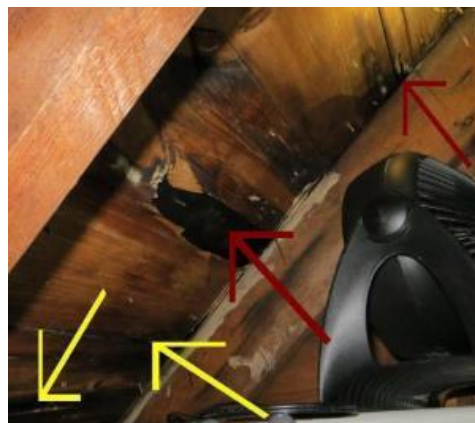
4.6 Evidence of Leakage:

At the time of the inspection the roof decking was dry but there is evidence of past leakage most likely from the chimney. The yellow arrows denote staining and the red denote areas of decay and even a missing section of the decking material. Monitoring this area over time is needed.

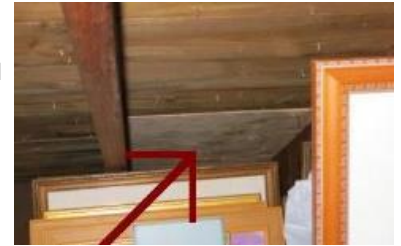
4.15 Evidence of Leaks on Interior of Attic:

There is water staining on the underside of the roof decking or rafters as previously noted in the area of the chimney. The stains are not currently wet nor do they have an elevated moisture content. There is evidence of repairs made to the decking on the rear left hand side. No comment is made as to the effectiveness of the repair, other than it was not leaking at the time of the inspection. This will need to be monitored over time.

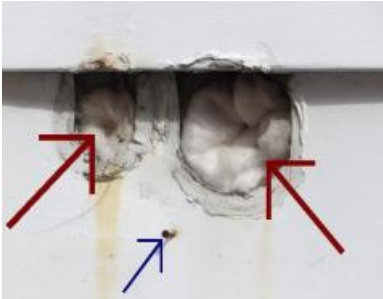
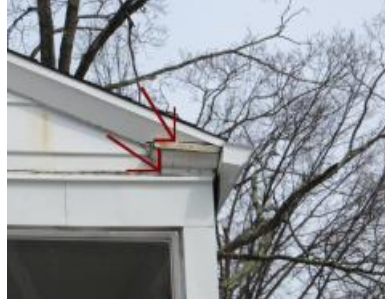
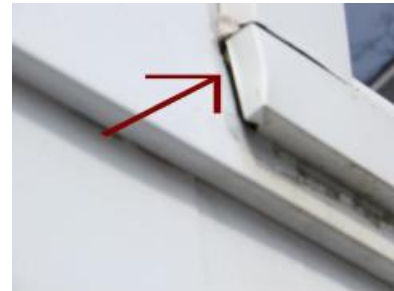
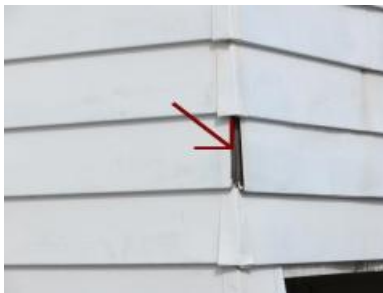
5.3 Siding Condition:

Physical damage was noted to several areas that need repair. this will keep water from entering and getting behind the siding

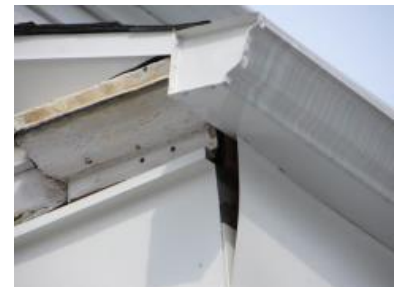
5.5 Fascia & Rake Boards:

The trim needs some minor repair to prevent further deterioration or water entry.

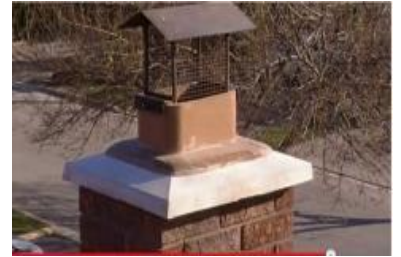
5.27 Chimney Cap or Crown:

Installation of a chimney cap is highly recommended to prevent water from entering the masonry stack or entering the wood chase causing deterioration. This is an example of a correctly built chimney cap. it extends past the brick to divert the water away from the top row of bricks.

The mortar joints between the bricks at the top of the exterior portion of the chimney are in need of repointing. Some of the areas have been patched with silicone which was poorly applied. I suggest having a mason evaluate and make any necessary repairs.

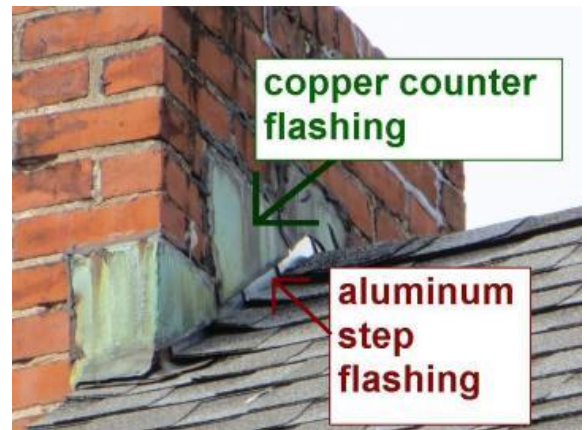
5.30 Flashing:

One of the most important issues concerning the use of copper is the chemical reaction between copper and other materials. Chemical reactions are responsible for corrosion, staining, and even the green patina that develops on copper surfaces over time. When dissimilar metals are in contact with one another in the presence of an electrolyte, galvanic action occurs, resulting in the deterioration of the metal at an increased pace. Due to this condition, monitoring this over time will be necessary.

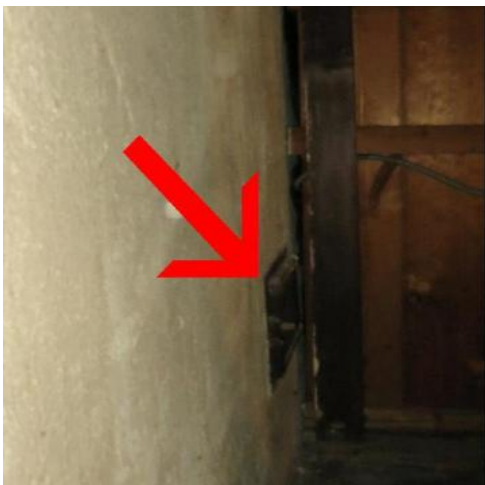
5.31 Ash pit Present:

There is an ash pit below the fireplace. I were unable to access the cleanout in the basement due to the finished basement walls.

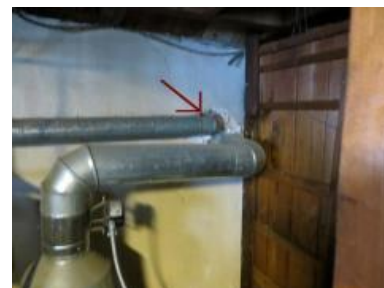
6.5 Flues, Vents, Plenum:

The heating systems exhaust flue pipe that is entering the chimney is sealed with some type of fiberglass looking insulation. My recommendation is that the flue pipe be set within a fireproof thimble or that the exhaust pipe be enclosed with a fire retardant mortar. Have your heating technician make the necessary repairs.

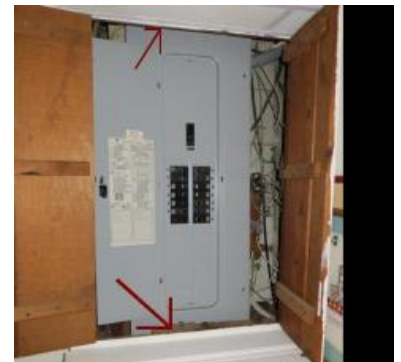
7.5 Panel Cover Removed:

Recommend making modifications to the wood access door so the panel cover can be easily removed. Exercise equipment should be relocated to allow emergency access to the panel.

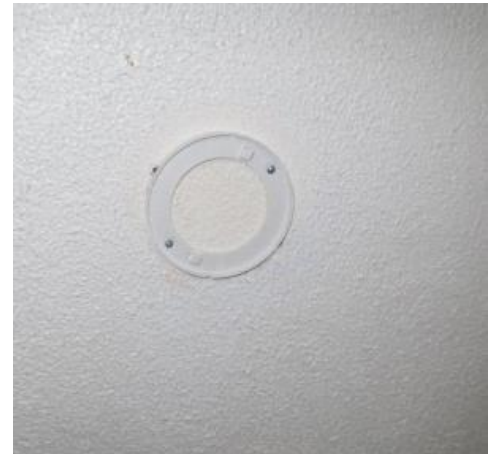
7.14 Smoke Detectors:

It is important for you to test them on a regular basis, monthly at least. There was one smoke detector missing over the top of the basement stairs. Also consider installing a combination carbon monoxide, and smoke detector.

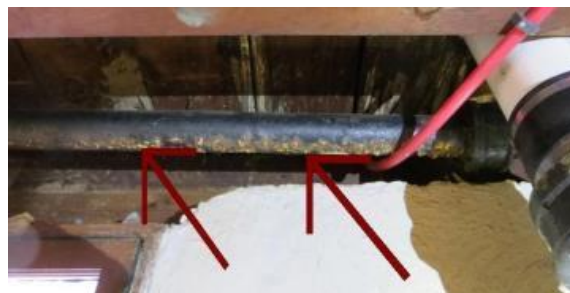
8.8 Waste Piping Condition:

In the basement equipment room, a section of the waste pipe above the window needs attention. There are visible signs of deterioration, I recommend you contact a licensed plumber to correct this problem.

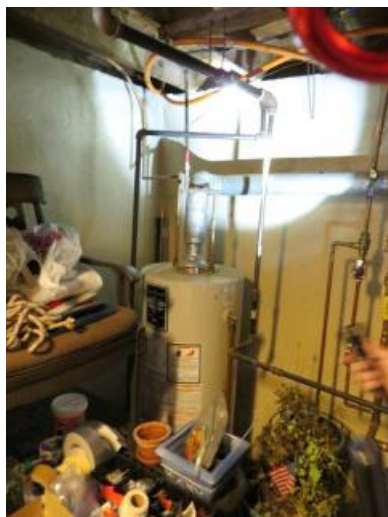
8.10 Model/ Serial Number/ Size:

The average service life for a water heater is 10 - 12 years. We were unable to get close enough to the water heater to check the name plate for information on its age or size do to the amount of storage items blocking access.
