PALLADIAN
HOME INSPECTIONS, LLC
148 Woods Way Dr Southbury CT
203-217-9450 adaigle242@charter.net

Confidential Inspection Report

Report: sample

April 1, 2013

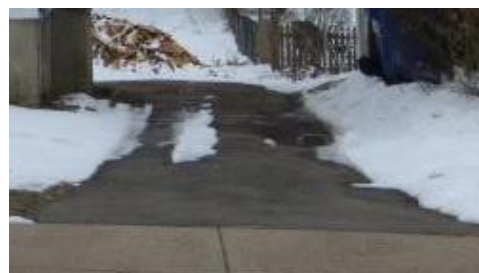
2.3 Driveway Paving Material:

Asphalt, the driveway surface material is in functional condition with only normal deterioration with no major heaving or cracking noted.

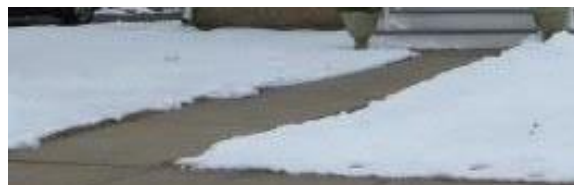
2.5 Walkway Condition:

At the time of the inspection, the walkway surface material is in functional condition with only normal deterioration noted for its age.

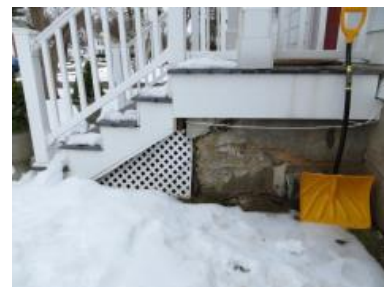
2.6 Entryway Stoop:

The entryway stoop appears to be straight and level, is butted tight up to the house and is in functional condition at the time of the inspection.

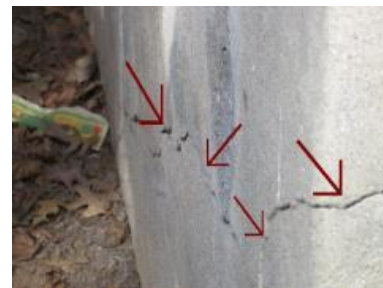
3.4 Visible Foundation Wall Cracks at Exterior:

Shrinkage cracks are hairline cracks that are caused by the evaporation of water in the mix. This is a normal condition. Seventy-five percent of all shrinkage cracks appear in the first year. At the time of the inspection no inward movement was noted.

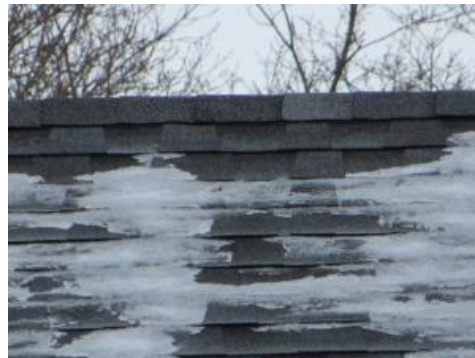
4.2 Roof Covering Materials:

Architectural asphalt composition shingles. These consist of cellulose mat, asphalt impregnated with colored gravel on surface. Shingles are applied in horizontal rows which were straight and even. The roof lines looked straight and even with no major dips or depressions noted. The shingles looked to be lying flat with no signs of cupping or curling noted. The shingle particulate still looked to be mostly in place. The condition of the roof covering material is consistent with a newer looking roof showing no deficiencies at the time of my inspection. The life expectancy given is the best estimate of the inspector, assuming proper maintenance. The actual life of the roofing materials used can be influenced by external sources like weather extremes, conditions caused by trees and vegetation, and mechanical damage.

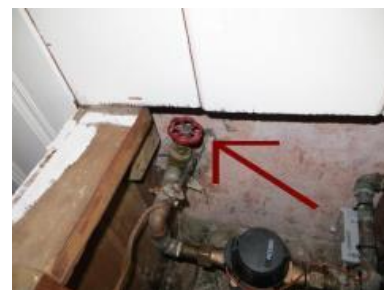
8.3 Main Water Line Cutoff Location:

Basement level wall.
